# ***Lessons Learned from Failures Involving Geofoam in Roads and Embankments***

**Manhattan College Research Report No. CE/GE-99-1**

**John S. Horvath, Ph.D., P.E.  
Professor of Civil Engineering**

**April 1999  
(Revised July 1999)**

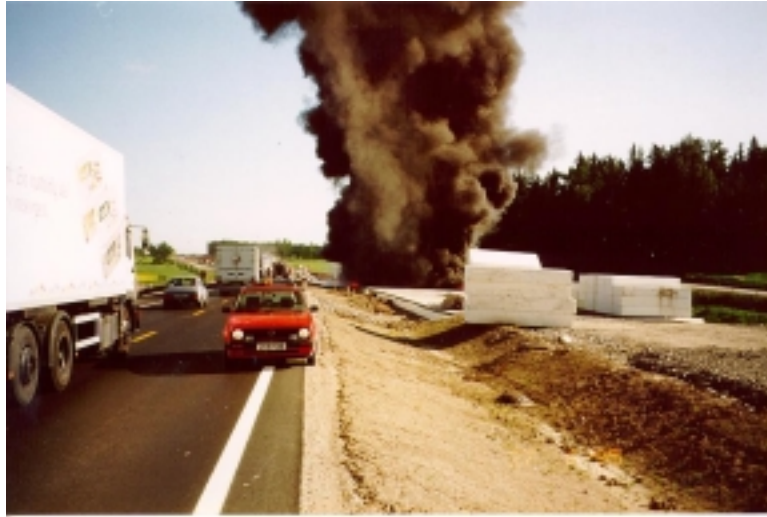
**Figure 1. Fire causing total loss of non-flame-retardant EPS-block geofoam being used as lightweight fill on a road project (Euroroad E6 in Vestby, Norway). This is one of only two known projects in the world where there was a total loss of EPS-block geofoam due to fire. The loss in each case was due to contractor error (courtesy of Mr. Tor Erik Frydenlund of the Norwegian Road Research Laboratory).**

Despite the worldwide availability of flame-retardant EPS-block geofoam, its use is neither universal nor guaranteed. Reportedly, flame-retardant EPS-block geofoam costs up to 10% more than non-flame-retardant EPS-block geofoam due solely to slightly higher raw material cost so it has been the practice in some countries not to specify flame-retardant EPS-block geofoam for economic reasons. This means that non-flame-retardant EPS-block geofoam is vulnerable to ignition during construction when the geofoam is exposed and there are potential sources of ignition from both construction operations (e.g. flame-cutting and welding of steel) as well as vandalism. Once the geofoam is covered, flammability is neither an issue nor a concern.

Frydenlund and Aabøe (1996) reported that two fires involving EPS-block geofoam have occurred in Norway during the period 1972-1995 (standard practice in Norway is, or at least was until recently (1998), not to specify flame-retardant EPS-block geofoam). Both fires occurred during construction and were due to welding steel members (not related to the geofoam blocks) too close to uncovered geofoam and thus considered to be contractor error. Total loss of the geofoam occurred within minutes in each case. Figure 1 shows one such fire. As dramatic as this photograph is, it should be kept in mind that these were the only reported fires during a 25-year period when hundreds of lightweight fill projects using non-flame-retardant EPS-block geofoam were constructed in Norway.

***In general, when a polymeric geofoam product is used, consider the potential for fire whenever the geofoam will be exposed to the atmosphere during construction.***

***For EPS-block geofoam in particular, do not assume that flame-retardant material will be supplied. Flame-retardant EPS-block geofoam should be specified explicitly if deemed desirable on a project.***

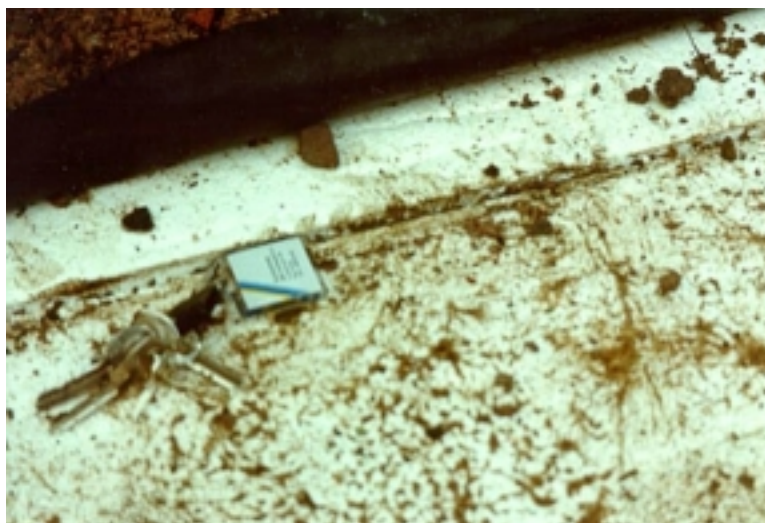
**Figure 2. Relative vertical movement of approximately 5 mm between blocks of EPS geofoam used as lightweight fill in the Matlingeweg street reconstruction project in Rotterdam, The Netherlands. This movement occurred within an portion of the street with a single layer of geofoam blocks and contributed to premature failure of the overlying asphaltic concrete pavement after one month of service (courtesy of Dr.-Ir. Milan Duškov of Oranjewoud International).**

Duškov (1994, 1997a, 1997b) discussed a project in Rotterdam, The Netherlands, that involved the reconstruction of a street named Matlingeweg. The existing soil subgrade was partially replaced with EPS-block geofoam as a key part of the reconstruction to permanently reduce overburden stresses on underlying soft soils. A portion of the reconstructed street used only a single layer of EPS blocks 500 mm thick. The remaining portion used two layers of blocks. Within one month after the reconstructed road was opened to traffic in late 1990, cracking sufficient to be considered failure was observed in the asphaltic concrete wearing surface of the pavement system. All cracking occurred in a portion of the road with only a single layer of EPS blocks. A subsequent forensic investigation revealed that the EPS blocks had shifted at their joints. Relative movements between blocks both vertically (up to 5 mm as shown in Figure 2) and horizontally (resulting in gaps as much as 20 mm wide as shown in Figure 3) were found. The movements were attributed to failure to ensure intimate block contact during placement which would have maximized inter-block friction. No type of mechanical (barbed-plate) inter-block connector was used for any of the vertical joints but, in fairness, such connectors are rarely if ever used in this way. In addition, a line of vertical joints between blocks happened to coincide with one of the vehicle tire paths on the overlying asphaltic concrete which tended to concentrate vertical live loads at this particular joint location. This street was subjected to heavy traffic, including trucks, which certainly exacerbated the situation.

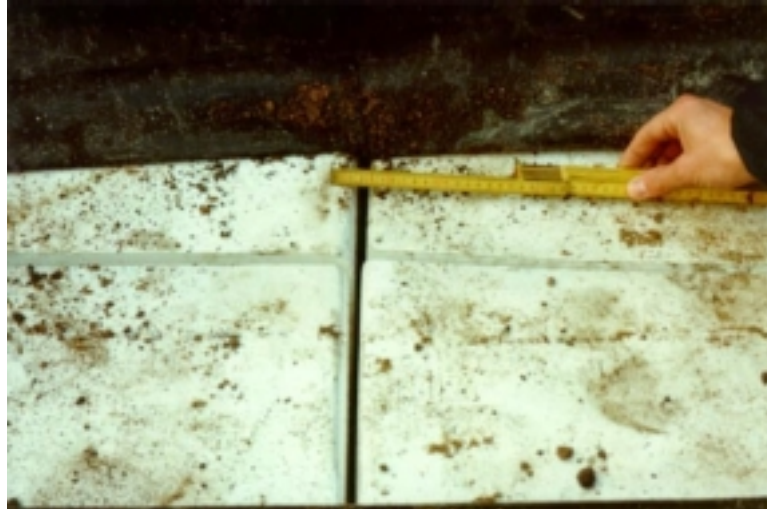
**Figure 3. Relative horizontal movement and a resulting gap of approximately 20 mm between blocks of EPS geofoam used as lightweight fill in the Matlingeweg street reconstruction project in Rotterdam, The Netherlands. This movement occurred within an portion of the street with a single layer of geofoam blocks and contributed to premature failure of the overlying asphaltic concrete pavement after one month of service (courtesy of Dr.-Ir. Milan Duškov of Oranjewoud International).**

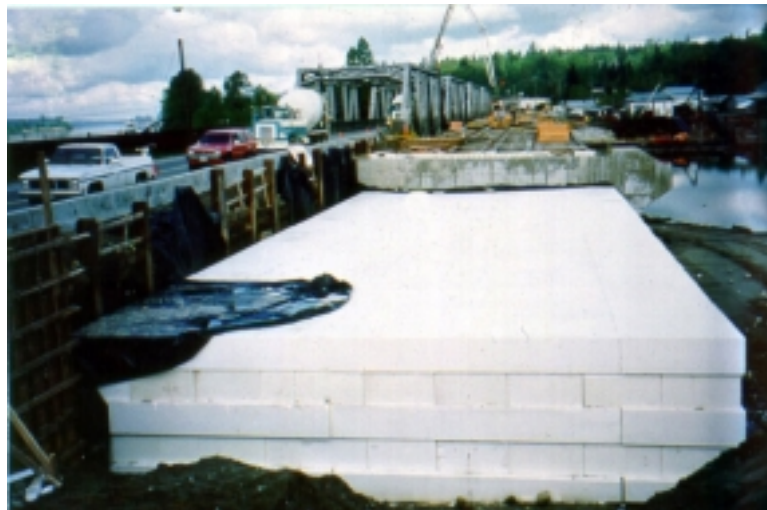
**Figure 4. New bridge approach fill under construction utilizing EPS-block geofoam as lightweight fill on Highway 7 at the Stave River in British Columbia, Canada. Important design details such as multiple layers of geofoam blocks and alternating block orientation, both of which contribute to the individual geofoam blocks acting as a single homogeneous mass, are illustrated (courtesy of Mr. Michael Tobin of AFM<sup>®</sup> Corporation).**

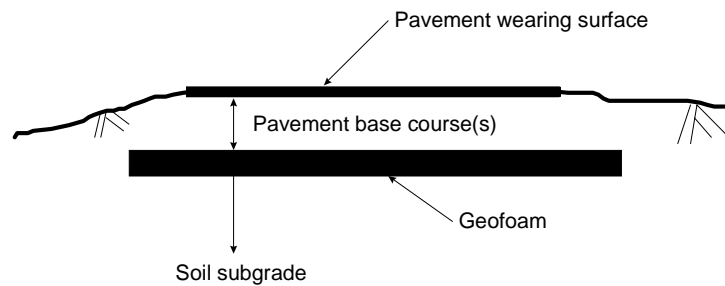
Figure 5 illustrates a cross section through a typical insulated road pavement. The original goal was to use a sufficiently thick layer of geofoam (typically 50 to 100 mm) so that the soil subgrade beneath the geofoam would not freeze. One benefit of this is that there would be no frost heaving for subgrades composed of soil with heave potential. Another benefit is that there would also be no subgrade thawing in the spring so that thaw-weakening of the soil subgrade, the leading cause of potholes in pavements, would not occur either. It was common in early designs to place the top of the geofoam layer as close to the pavement surface as practical (of the order of 300 mm or less) based on calculated stresses from wheel loads compared to the strength of the geofoam material used.

**Figure 5. Schematic cross section of key components of an insulated pavement system.**

In later years, designs were modified to allow some freezing of the subgrade beneath the geofoam. This was for economic reasons (a thinner panel of geofoam could be used) as well as to create smoother transitions to adjacent paved sections without insulation. Regardless of whether full or partial subgrade freezing protection was desired, the use of insulated pavements was viewed as less expensive than excavation and replacement of heave-susceptible soils or frequent, periodic maintenance of potholes, etc.
